# Lucky Discovery: GIS Project Reveals Unseen Threat from West Nile Virus

By Paul Beach  
Sault Ste. Marie  
Innovation Centre

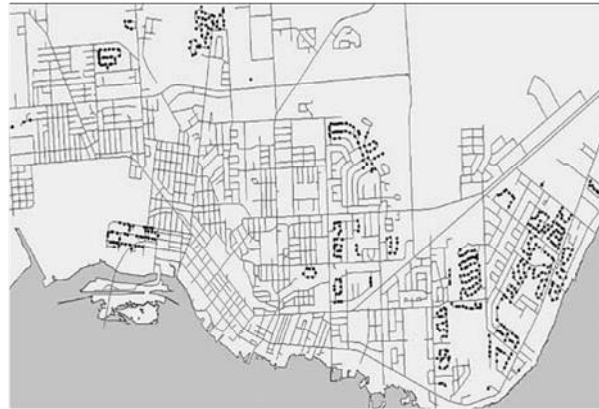
*This map shows the locations of PUC submersible transformer vaults in Sault Ste. Marie.*

Sault Ste. Marie has more than 500 submersible transformer vaults. They were installed during the 1960s through the 1980s in many communities in North America.
